Navajo Abandoned Uranium Mine

Site Screen Report

NA-0343 AUM Site

Navajo AUM Northern Region

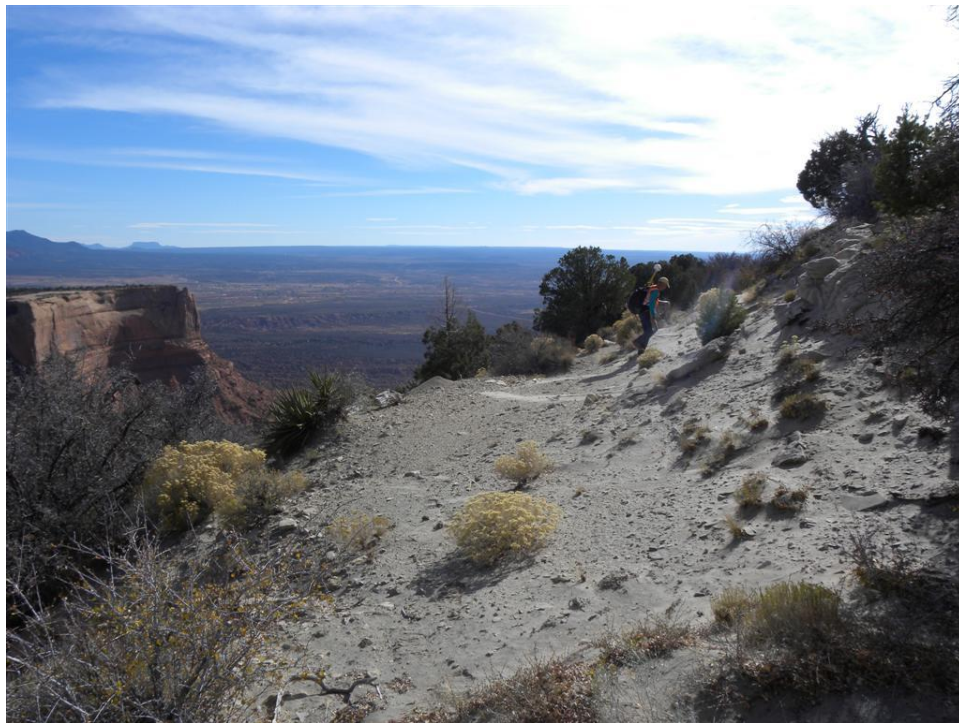
Photo 1. Mine site cliff face

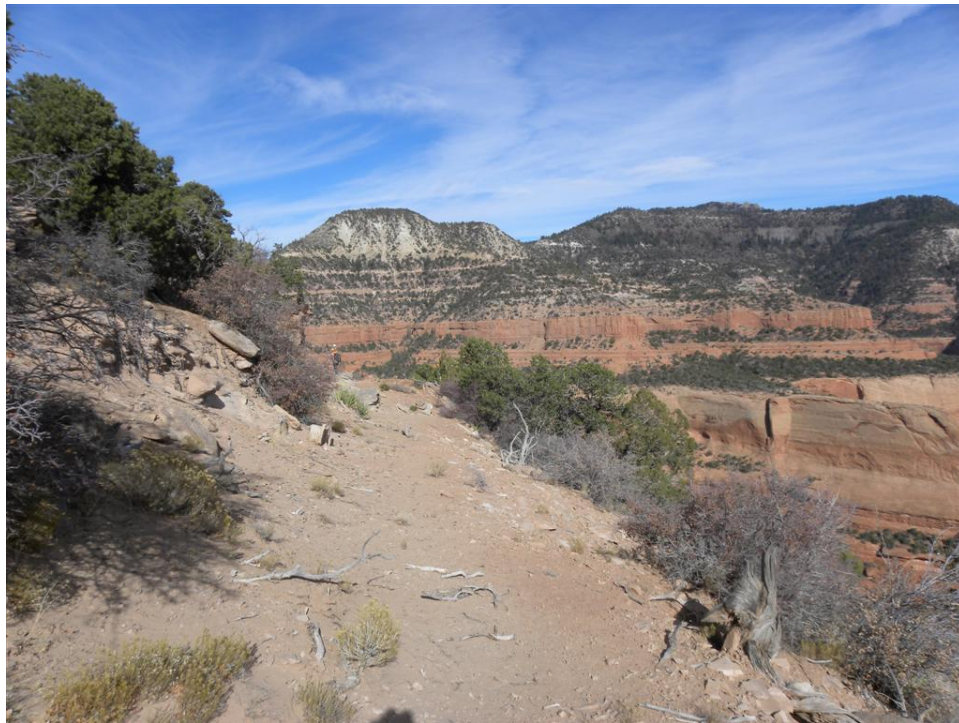
Photo 2. Mine site cliff face

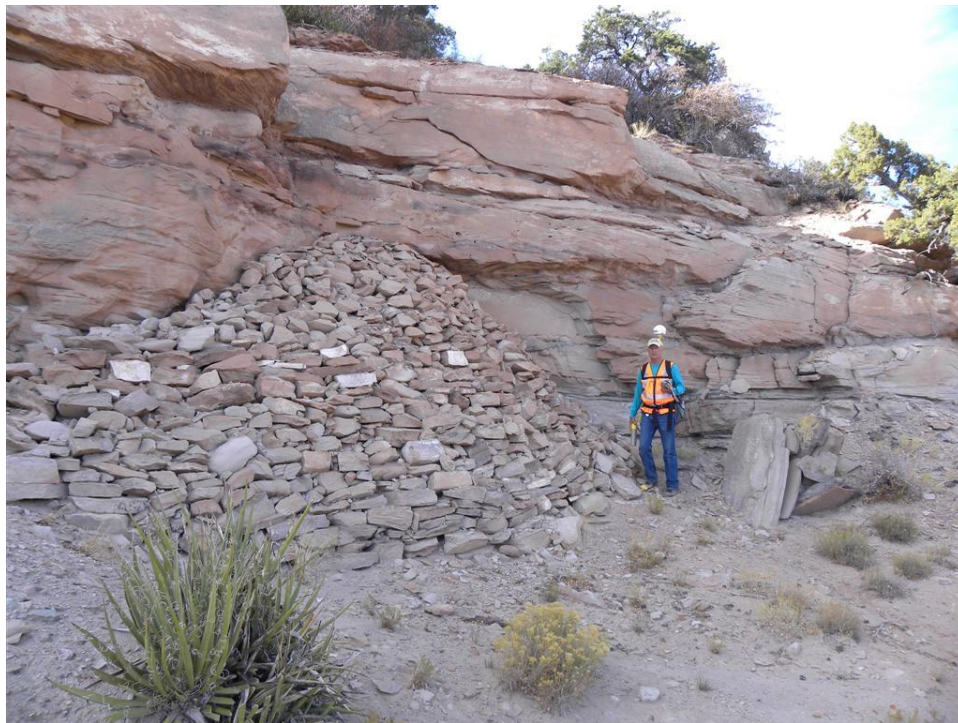
Stone sealed adit at apex of site

Waste debris beneath adit downslope 75' x 50', with a total estimated volume of 694 yd³

Photo 3. Sealed adit and waste debris

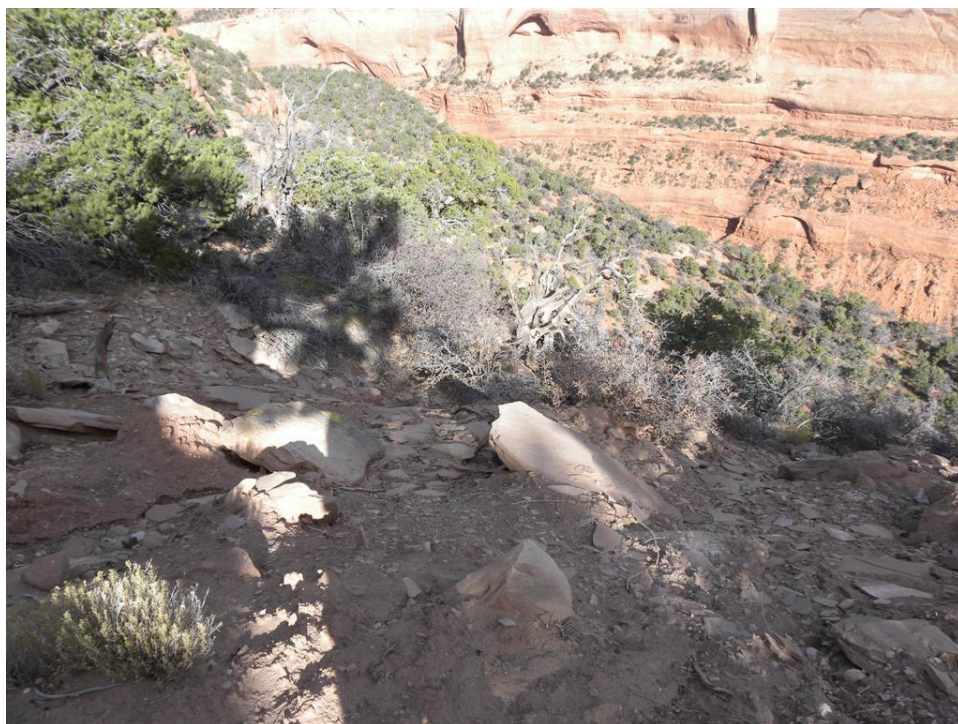
Photo 4. Waste rock
